# A RESEARCH STUDY ON INTERNAL CORROSION OF HIGH PRESSURE BOILERS

## SECOND PROGRESS REPORT

Steam and Water Division  
Kreisinger Development Laboratory  
Combustion Engineering, Inc.  
Windsor, Connecticut

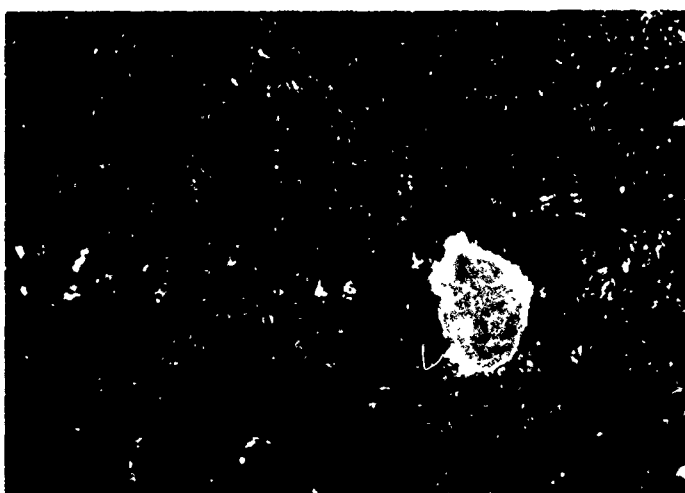
It is interesting to note that corrosion appeared to occur in the horizontal preheater during the clean-boiler caustic test. In this case, the attack probably occurred as a result of steam blanketing in this low-velocity horizontal run of tubing. Figure 11 shows the corroded surface.

**Fig. 11: Upper—View of old horizontal preheat furnace 3-in. tubing showing area of corrosion  
Lower—Close up of corrosion pits**

Hydrogen levels in excess of those of either the volatile or phosphate runs were experienced during this test. This appeared to be the result of corrosion due to steam blanketing in the low-velocity tube runs of the hori-

zontal-preheat furnace. Figure 11 shows the appearance of this corroded surface. The original pre-heater was, therefore, replaced.

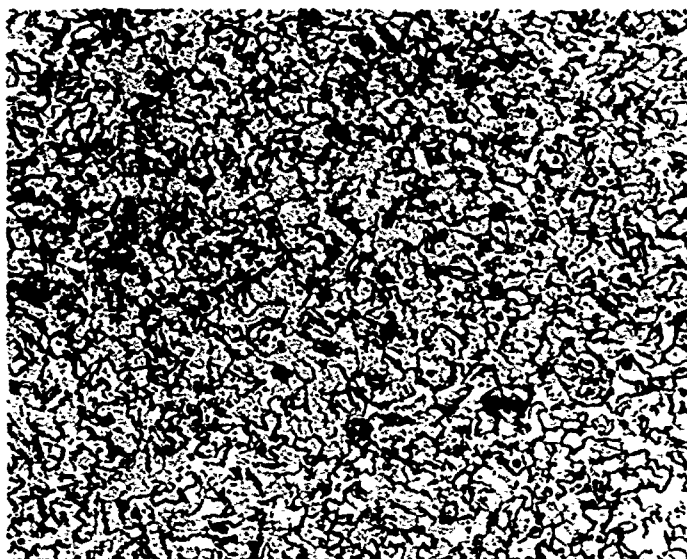
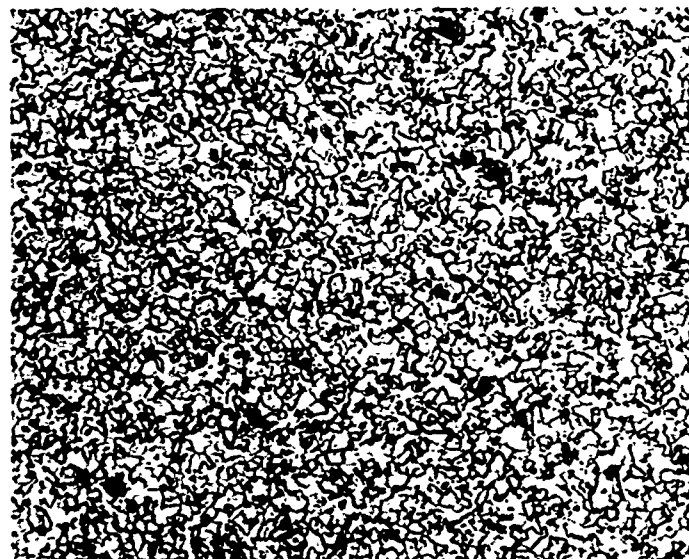
The first pair of photomicrographs (Fig. III-1) reveal that this tubing is received in a spheroidized condition. No changes in microstructure result from the nickel plating operation. Brazing at 1600 F and slow cooling over a 48-hour period yield a pearlitic microstructure as shown in the second pair of photomicrographs (Fig. III-2).

Fig. III-1: Upper—100x photomicrograph of "as received" SA-192 tubing showing spheroidized structure  
Lower—500x photomicrograph as above

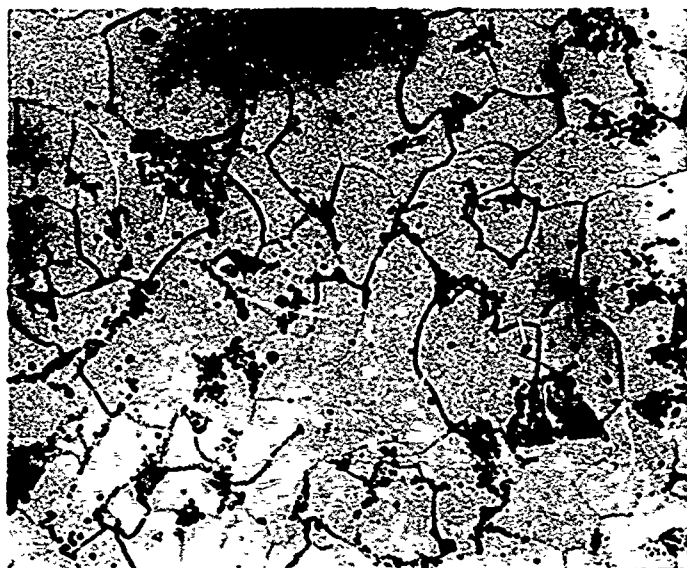
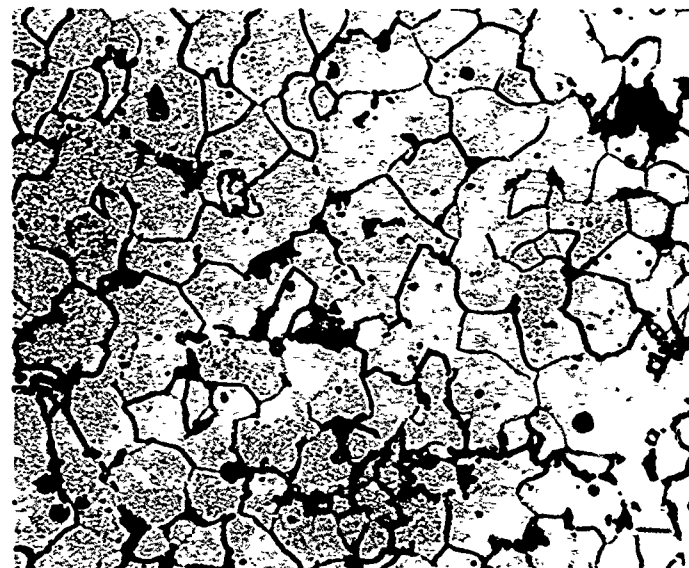
Fig. III-2: Upper—100x photomicrograph of SA-192 tubing after heat treatment showing pearlitic structure  
Lower—500x photomicrograph as above

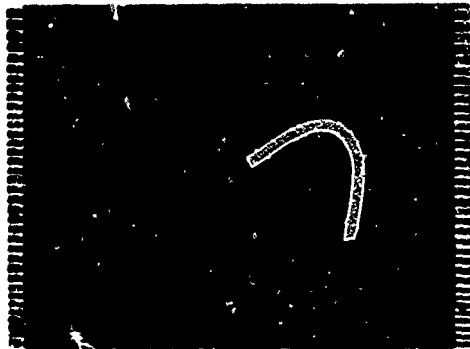
Fig. VII-4: Upper—Appearance of deposits formed on tube surfaces during the dirty boiler volatile test  
Lower—Tube surface after removal of deposits by chemical cleaning
